## Historic District Review Committee

Staff Report  
September 14, 2009

**CAPP 2009-0013 Hughes Residence: Main Block and Log Addition Renovations and Rear Frame Addition Demolition in the Bluemont Historic District. MCPI 648-19-6155.**

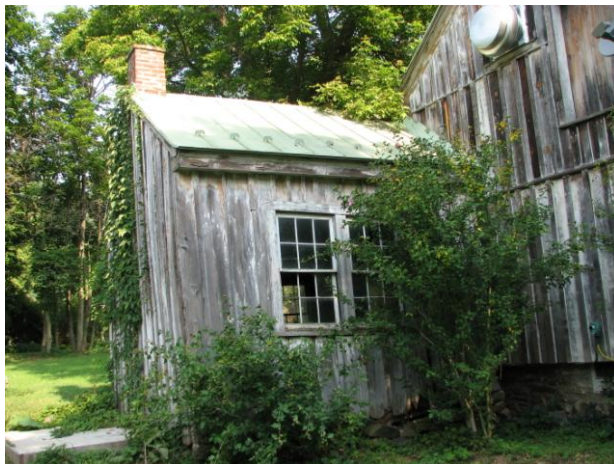
Photo 1: East elevation of frame addition proposed for demolition showing paired 6/6 windows.

Resources (ABOT Guidelines: Guidelines for Demolition and Moving, Guideline 2, pg. 148). **Staff also recommends that the window sashes, and possibly the frames, be salvaged, repaired, and used in the log addition for the three windows proposed along the rear elevation. The applicant should document through a window survey as required in the ABOT Guidelines to determine if these windows are not repairable.** Staff refers the applicant to the Windows section (pg. 105-11) of the ABOT Guidelines and Preservation Brief #9: The Repair of Historic Wood Windows for more guidance on survey and repair.

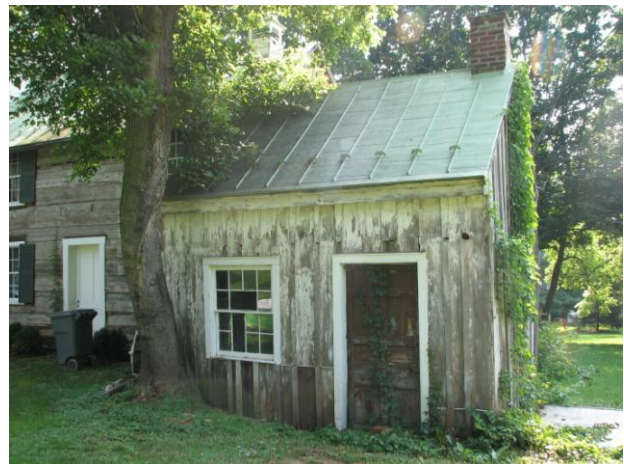
Photo 2: West elevation of frame addition proposed for demolition showing 8/8 windows and paneled door.

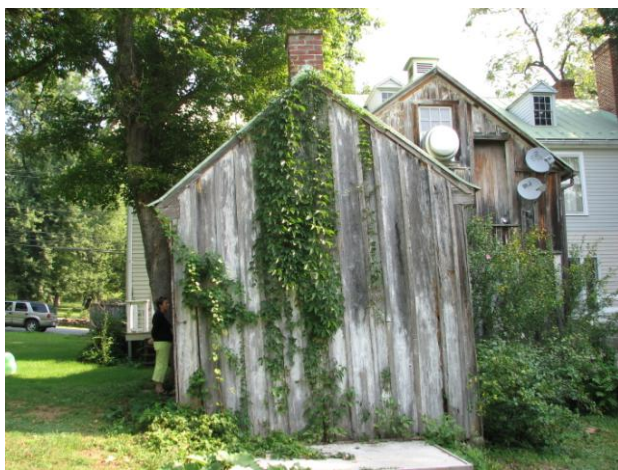
Photo 3: South elevation of frame addition proposed for demolition.

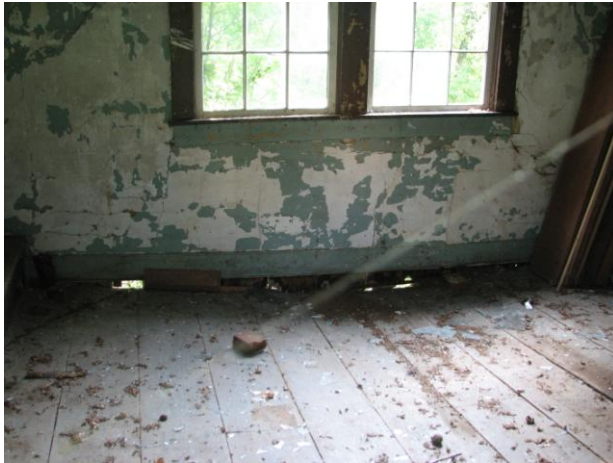
Photo 4: Demolition of floorboards

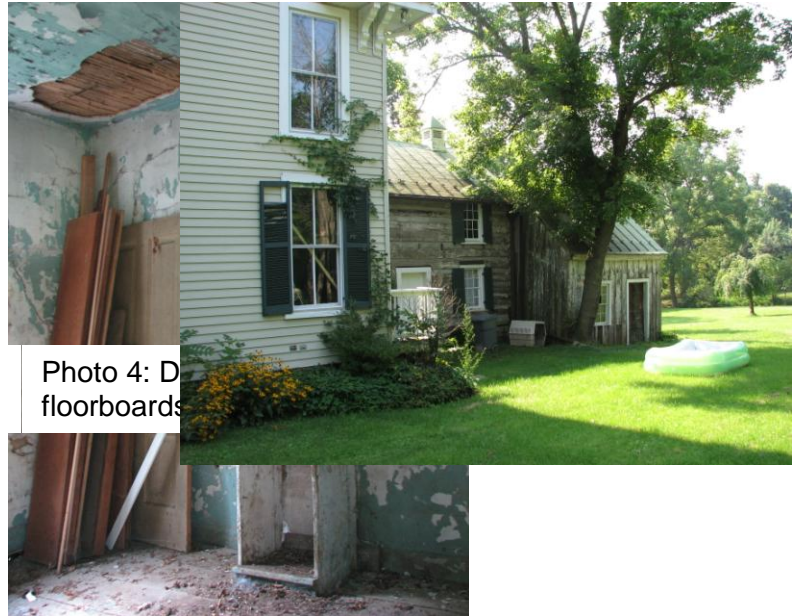
Photo 5: Interior view of chimney leading to stove pipe and example of broken plaster.

**However, the frame addition is in very poor condition and it would take considerable effort and resources to stabilize and rehabilitate it. It is also located to the rear of the Osburn-Scott House and out of direct view from the public way (Photo 8). The addition is of simple construction and could easily be recreated. Removing it would not damage the log addition to which it is attached. Relocating the building would not be possible due to its condition (*ABOT Guidelines: Guidelines for Demolition and Moving – Demolition Criteria c., f., h., i., and k., pg. 148*).**
